ISLP Peru 2025 Report - Project Qoricocha

A Sustainable Future for the Qquenco Community Through Engineering and Indigenous Knowledge

July 28th, 2025 – August 12th, 2025

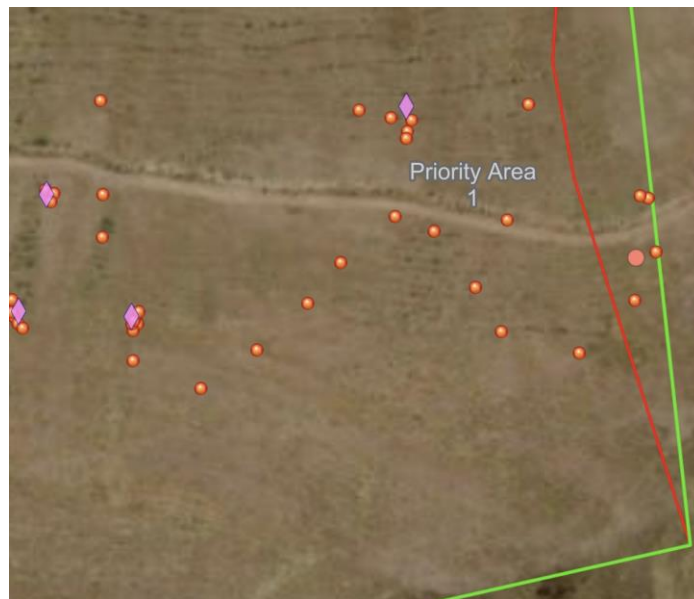
Figure 2: Example of Transect Method

The Transect method used involved students travelling across a priority area while changing elevations in a zig-zag pattern. This allowed data to be collected across different areas and elevations such that data representing the wide range of the various planting areas could be collected. Using the FieldMaps app, a relatively accurate location of each tree was recorded, along with the tag number, circumference, diameter at breast height, tree height, and species.

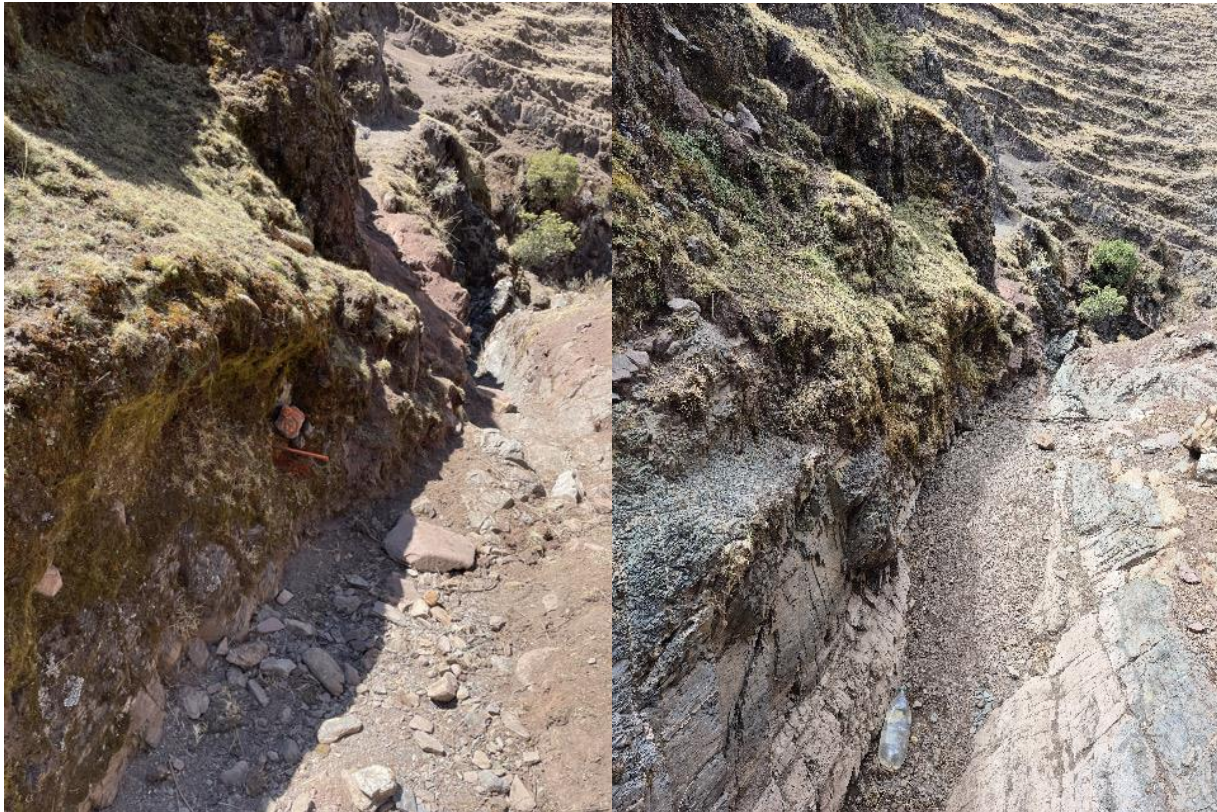
Figure 2: Before and after images of stake 5 location.

In the figure above, the location of the pictures is slightly different, but it is evident that the stake and the rock marked with the stake number had disappeared.

The problems with finding the stakes were the homogenous environment and the stakes' small profile. Much of the canyon was monochromatic and peppered with identical, dry yellow plants that made it hard to use the background of the 2024 photos as a reference. Additionally, the stakes only pointed out around two feet from the canyon wall, and the stake and canyon colors were quite similar. However, orange paint was used to mark both the stake and a landmark close to the stake to make each area easier to find.

Ironically, the prevailing problem with locating old erosion stakes was erosion. Ultimately, the team was able to find all five areas where the 2024 stakes were planted. However, only two stakes were still in place in the canyon wall. In the other three areas, the team used landmarks in the picture to confirm the areas of the stakes, but much of the soil surrounding the stakes' original location had clearly eroded. Additionally, the stakes and the landmarks marked by the 2024 group were nowhere to be found anywhere in the canyon.

Since five of seven erosion stakes were swept away, future groups should use longer erosion stakes. It is clear that there is significant erosion year to year, so to prevent the stakes from falling out, longer stakes should be adopted.

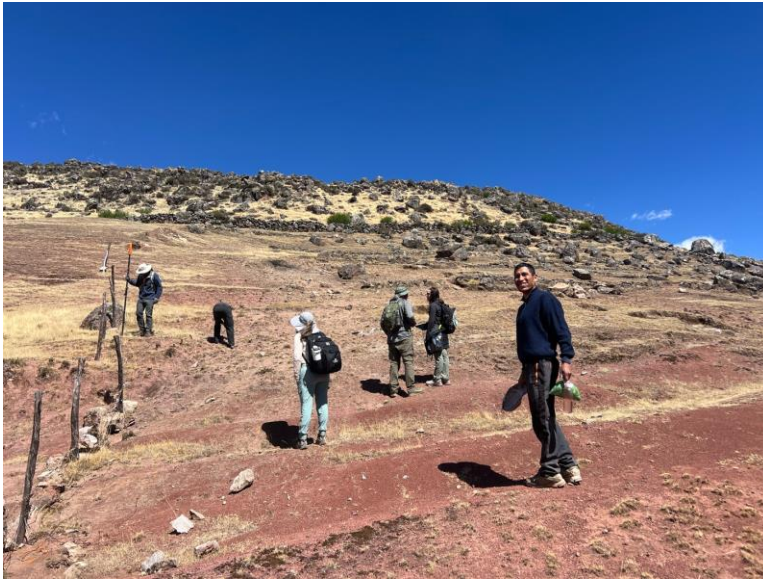
Figure: Image displaying the process of marking points for the contour lines.

We began the contour line process with Julio pointing us where to start near a boulder. We placed the Bad Elf over the point and on the iPad, we would log it as a name point, giving it an appropriate name. After we captured the point we placed plaster on the point and label it with the “p1” and the elevation that way we know the elevation of all the points without having to go back and measure previous points to recall the elevation. We repeated this process for the remaining of the contour lines.

We had a total of 5 people assisting in the operation of the placement of points: Julio, a Spanish speaking community member who told us what level he wanted the terraces to be and where to start and finish each contour line; Someone to translate between English and Spanish, someone to steadily handle the Bad Elf, someone to operate the bad elf software, and someone to place the plaster point and label.
